CIA IMAGERY ANALYSIS DIVISION

SEARCH FOR CIVIL DEFENSE SHELTER CONSTRUCTION, SHANGHAI, CHINA

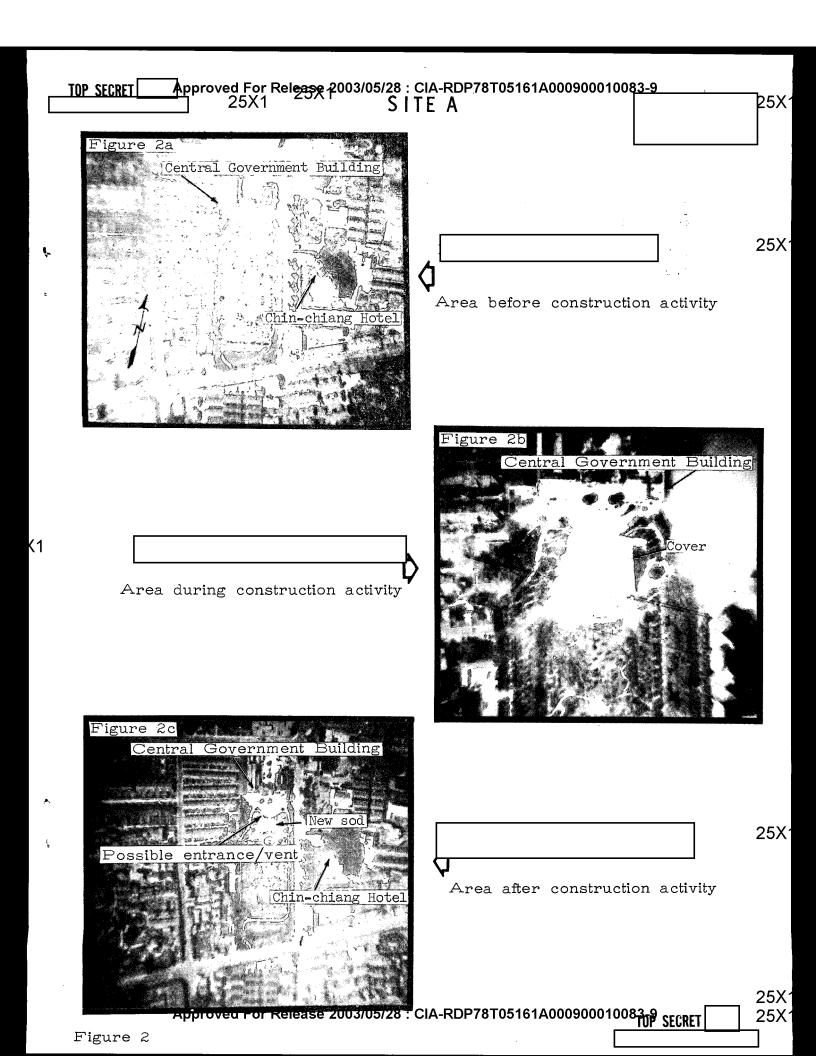
Approved For Release 2003/05/28 REW-RDP78T05161A000900010083-9
	CIA IMAGERY ANALYSIS DIVISION
25X1	•
	SITE ANALYSIS
Site A	a large or being constructed under a park in Shanghai in 1905. This shelter
¹ 25X1	A search of photography revealed the following: (1) no apparent construction
20/(1	activity observed (Figure 2a).
25X1	- the area between the circlein the park and the Central Government Building has been cleared; however, a walk is still present.
5X1	- the walk has been removed.
5X1	(4) - construction act- ivity is observed and there appears to be a cover over the probable excavation (Figure 2b). Dimensions of this cover are approximately 130 X 115 feet.
25X1	(5) the area is still cleared. However limited quality of the photography makes it impossible to determine stage of construction.
25X1	- the probable shelter is completed and the ground appears as it did originally except for 4 object, possibly entrances or vents, in each corner of the area (See Figure 2c). The dimensions of the newly planted sod area are approximately 100 X 85 feet.

NOTE: Construction activity above ground is observed only at the north end of the park.
being it wi	B - (31 13 15N-121 27 05E) - a shelter constructed in a park near Site A with a possible tunnel connecting the three central Government Building. No construction activity was expressed at this location on available photography.

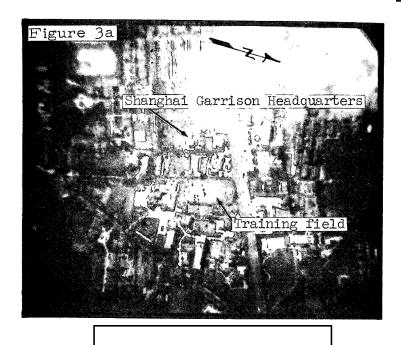
There is no scarring present in the training field.
